## High Frequency Monitoring and the Effects of Agricultural Water Withdrawal in the Savannah and Ogeechee River Basins

# Two-fold project goals

**Development of a pilot study to preserve in-stream water quality and in-stream flows below an urban pond complex using a real-time control system**

## Site Overview

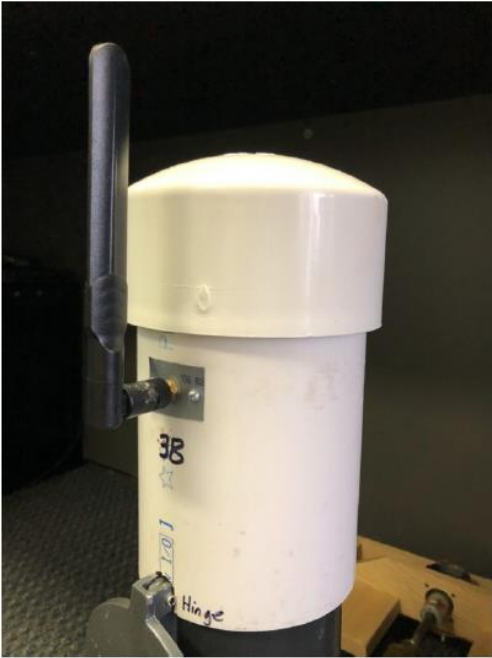
Figure 2 - Updated Antenna design

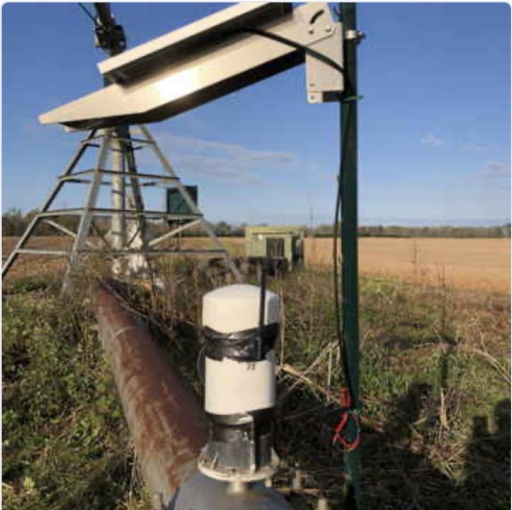
JRG-35

Installed @: Benny Mims Farm

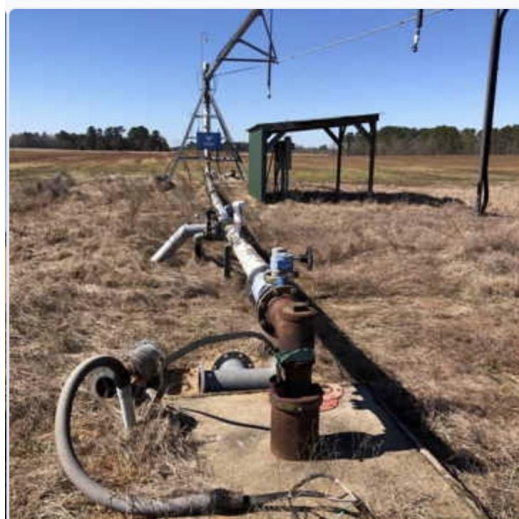
JRG-32

Installed @: Dual Creek Farm

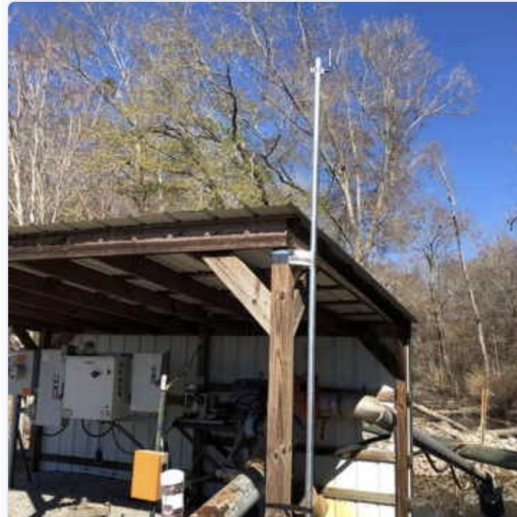
JRG-30

Installed @: Dual Creek Farm

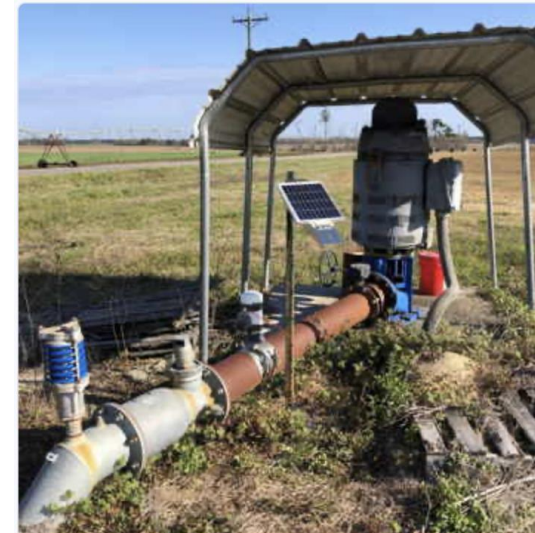
JRG-36

Installed @: Benny Mims Farm

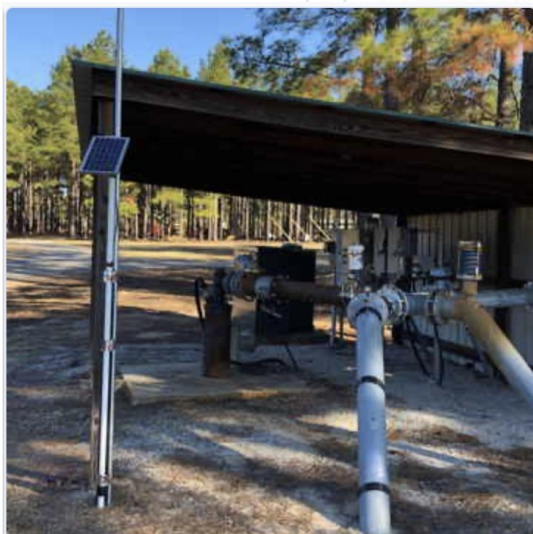
JRG-33

Installed @: Dual Creek Farm

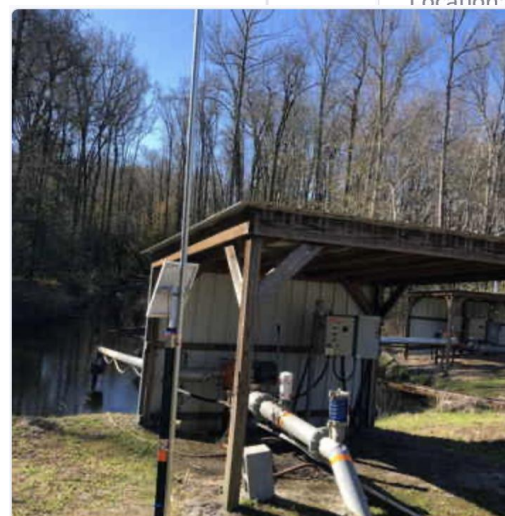
JRG-31

Installed @: Dual Creek Farm
