Lower Oconee River Watershed Management Plan

September 2018

Prepared by Pine Country Resource Conservation and Development Council, Inc.

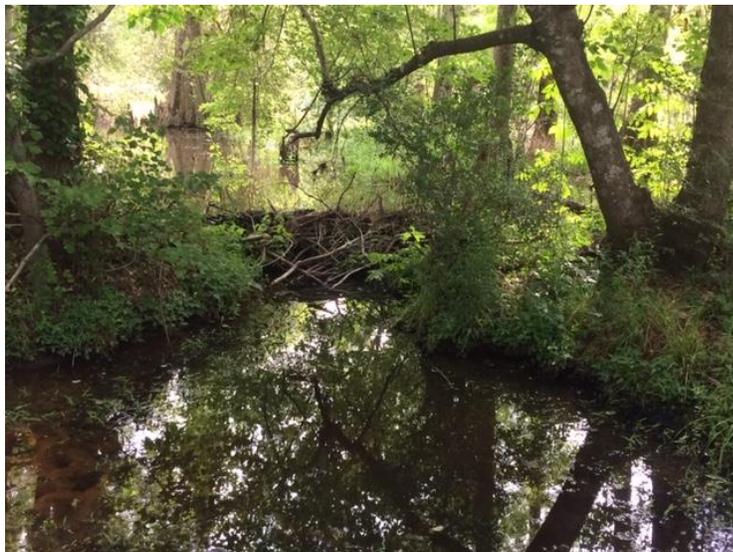
The visual survey along with the review of current aerial photography revealed that streams within the watershed appear to have adequate vegetated buffers due to the adjacent land use predominately being forestland with only portions currently undergoing harvesting operations. Agricultural lands in close proximity to streams within the watershed appear to have adequate vegetative buffers as well, with an adequate buffer being classified as a natural or vegetative buffer exceeding 25 feet measured perpendicular from the point of wretched vegetation.

Areas that drew attention during visual assessments as potential points of sediment loading included eroded areas directly adjacent to box culvert headwalls and bridge features on paved roadways in need of stabilization as well as the volume of unpaved public and private roads and associated drainage features that directly intersected streams within the watershed. Potential

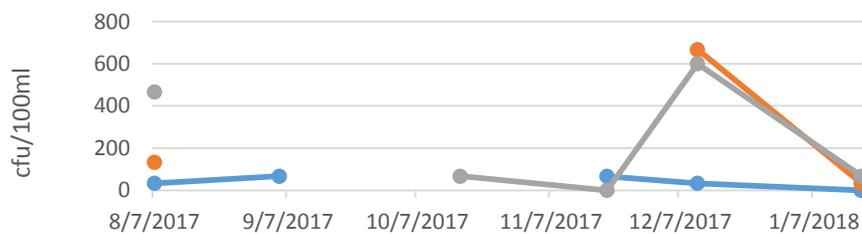
Lower Oconee *E. coli*.

| | 8/7/2017 | 9/5/2017 | 10/17/2017 | 11/20/2017 | 12/11/2017 | 1/18/2018 |
| —●— Limestone Creek | 33 | 67 | 7 | 66 | 33 | 0 |
| —●— Peterson Creek | 133 | | | | 667 | 33 |
| —●— Lotts Creek | 466 | | 67 | 0 | 600 | 67 |

Overall, water quality monitoring data reflected no current problems with sediment loading. At no time during the six month sampling period was settleable solids present above a trace amount ($\geq 0.5\text{ml}/1000\text{ml}$) in any sample taken, and the highest NTU levels were recorded in the Oconee River which is identified as a health water. The fecal coliform levels recorded for Limestone Creek and Peterson Creek did not exceed the current State standard at any time during the six month sampling period; however, Lotts Creek, which is currently not listed as impaired for fecal coliform, did exceed the current State standard during the month of August.

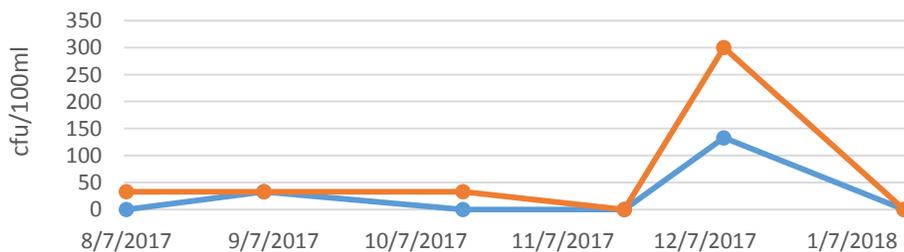
Oconee River *E. Coli*

| | 8/7/2017 | 9/5/2017 | 10/17/2017 | 11/20/2017 | 12/11/2017 | 1/18/2018 |
| —●— Site 11 | 0 | 33 | 0 | 0 | 133 | 0 |
| —●— Site 12 | 33 | 33 | 33 | 0 | 300 | 0 |

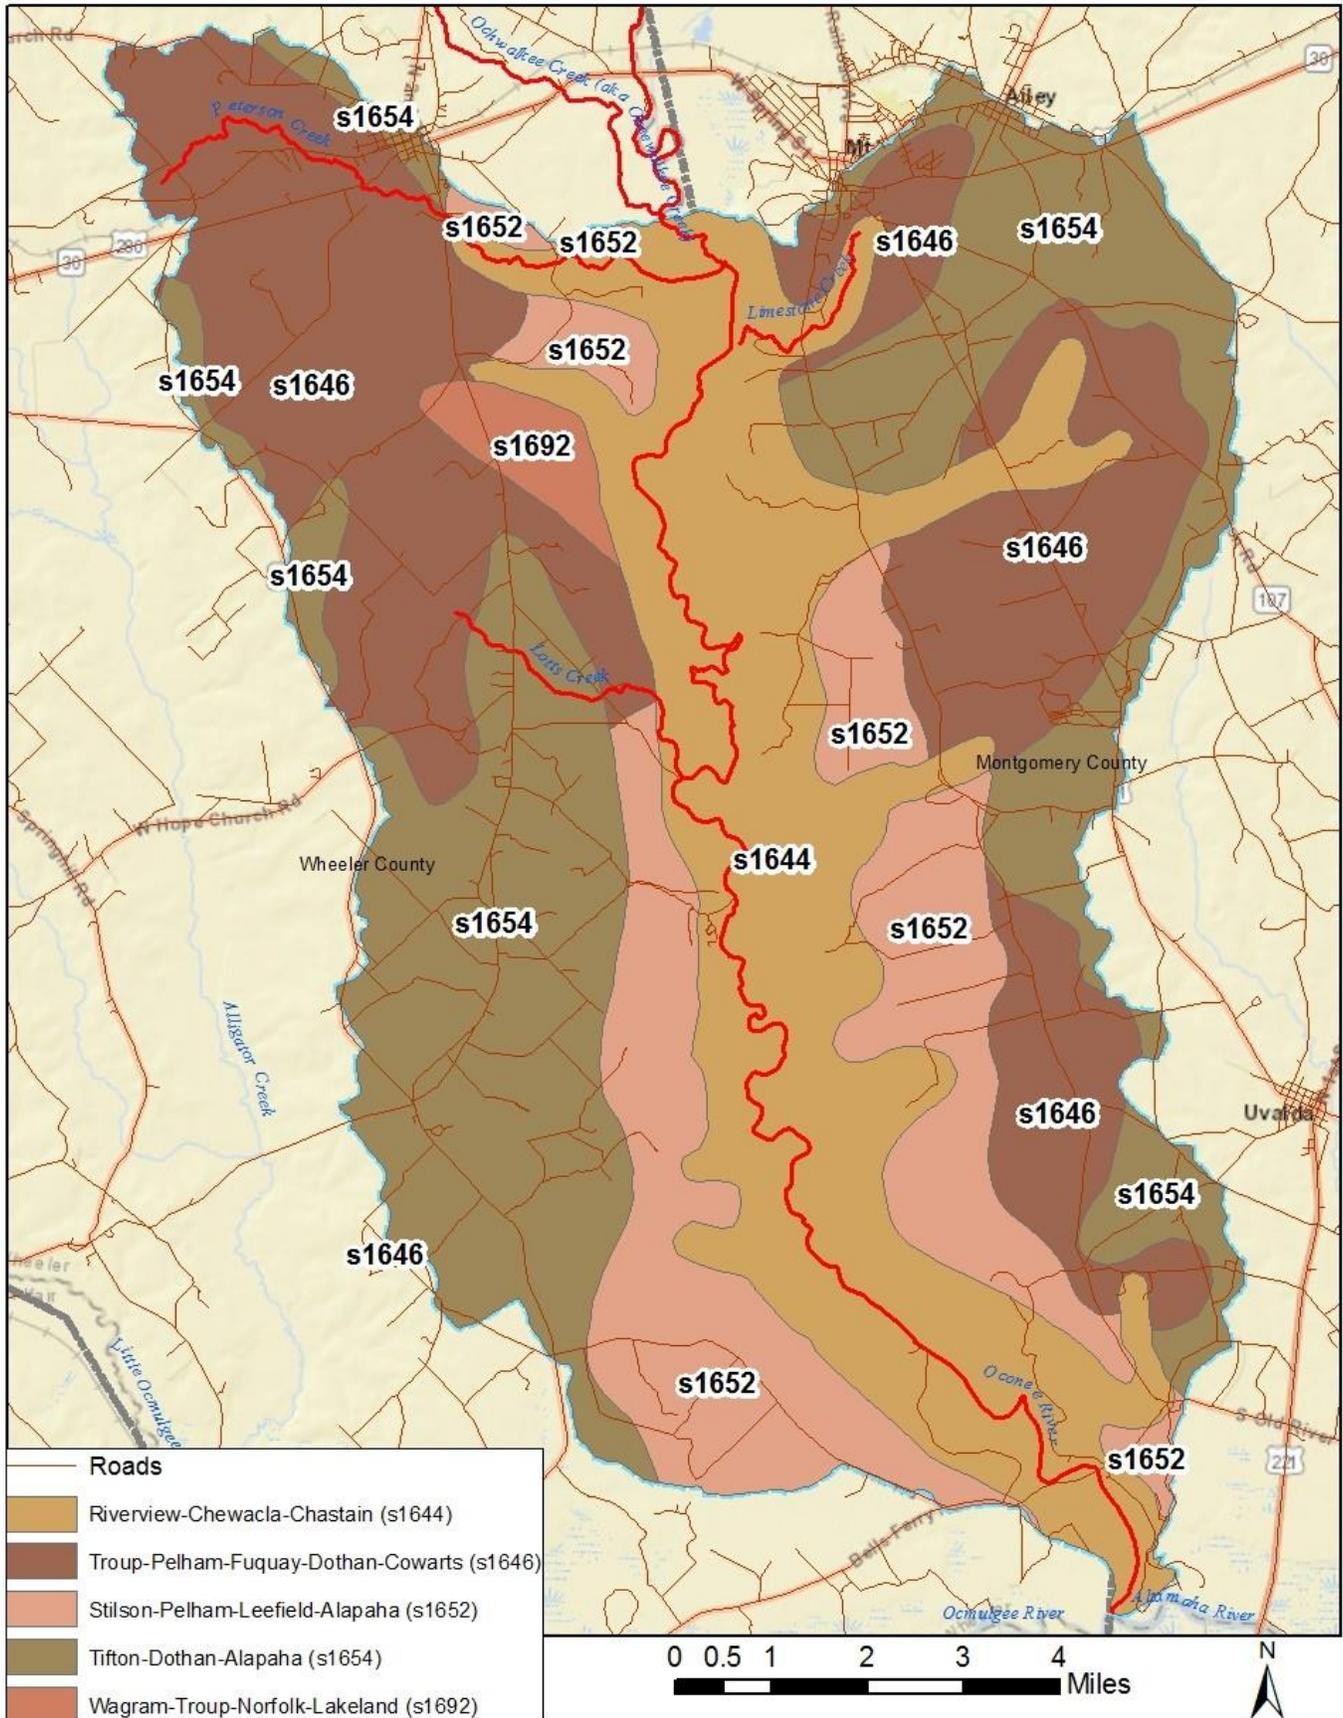
Map 3:

Lower Oconee Watershed Soils

The U.S. Department of Agriculture – Natural Resources Conservation Service has published soil surveys for each county in the Lower Oconee River watershed. All of the watershed is located in the Southern Coastal Plains Major Land Resource Area (MLRA). Dominant soils of the Southern Coastal Plains MLRA have mostly Ultisols, Entisols, and Inceptisols. They are generally very deep, somewhat excessively drained to poorly drained, and loamy. Specifically within this watershed, the dominant soil types are the Troup, Pelham, Fuquay, Dothan, and Cowarts Group along with the Tifton, Dothan, and Alapaha Group - (See Map 3).

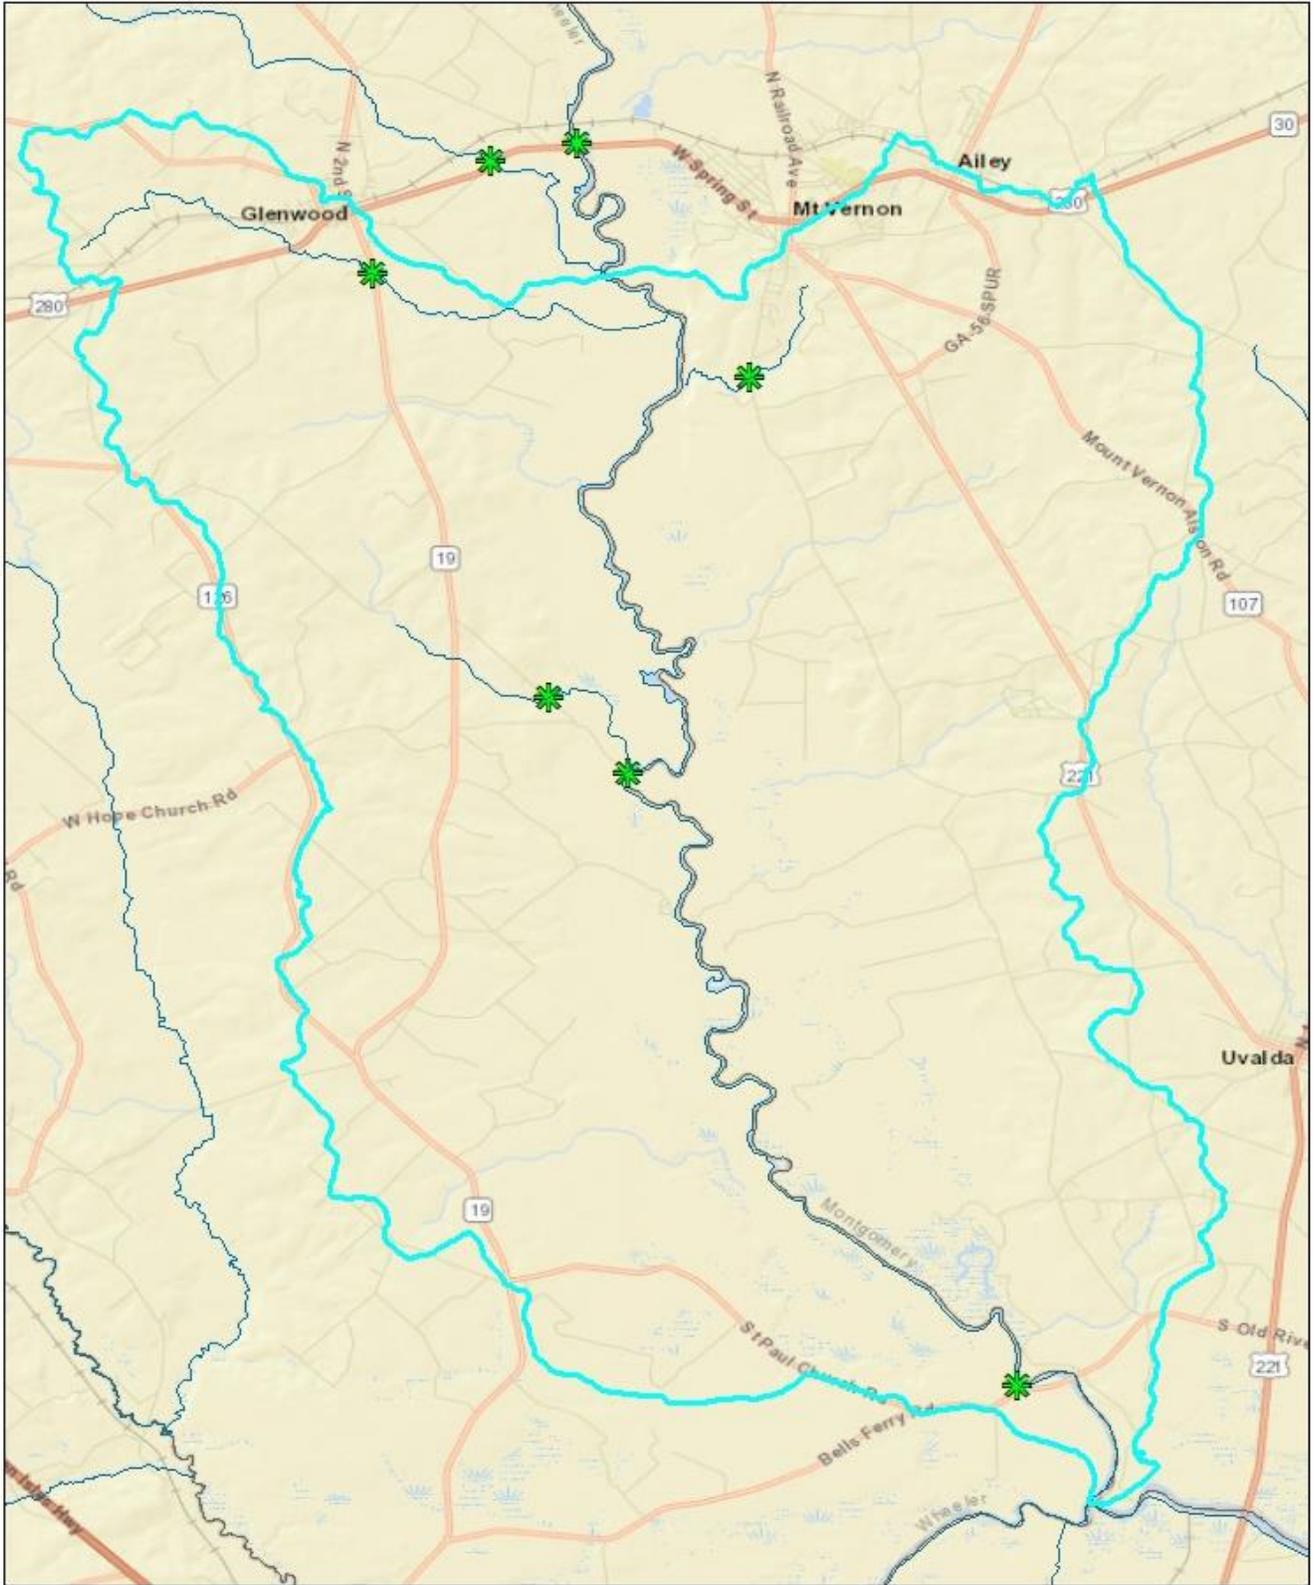
Map 8: Lower Oconee Monitoring Sites

Monitoring Sites

Water quality monitoring was performed by one individual on staff with the Pine Country RC&D possessing the appropriate Georgia Adopt-A-Stream certifications and following a watershed specific SQAP. The SQAP was developed to strategically sample throughout the watershed to better identify potential sources of pollution and areas having higher impacts on water quality. (See Map 8 for Sampling Locations)
